Pre-Construction Hazardous Building Materials Assessment

25 Ruben Crescent, Kemptville,
Ontario

October 13, 2016

Pinchin File: 116671

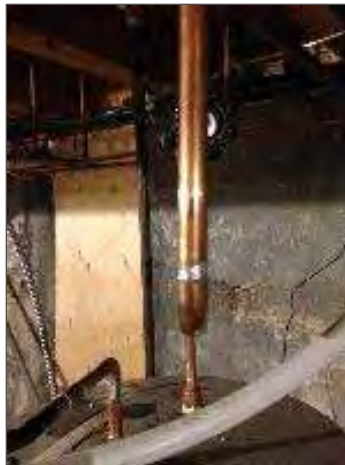
Insulated pipes were not found.

Photo 1 – Uninsulated pipes in the basement.

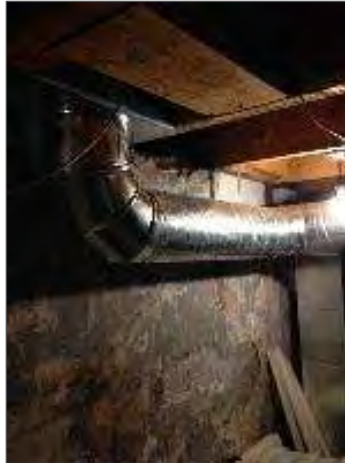
Insulated ducts were not found.

Photo 2 – Uninsulated duct in the basement.

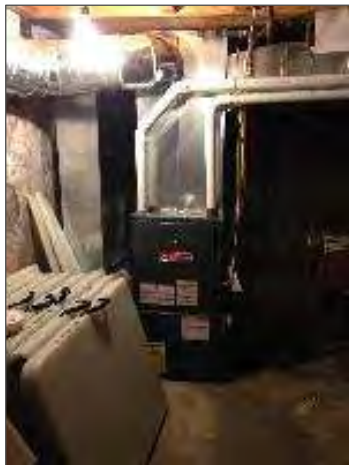
Mechanical equipment is either uninsulated or insulated with non-asbestos fibreglass.

Photo 3 – Uninsulated gas fired furnace in the basement.

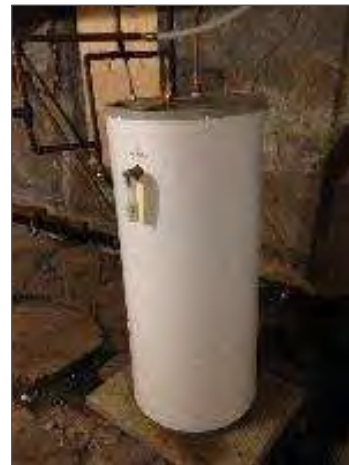
Photo 4 – Non-asbestos fibreglass insulated domestic hot water tank in the basement.

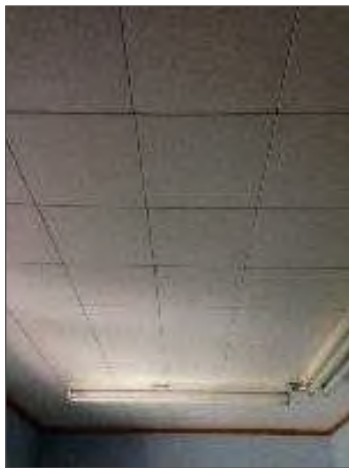
Photo 5 – Non-asbestos 12" x 12" glue-on acoustic ceiling tiles in the 2nd level classroom area.

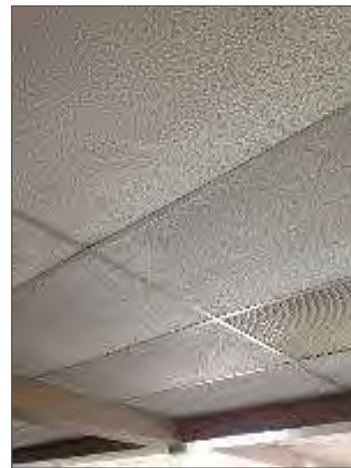
Photo 6 – Non-asbestos 24" x 48" lay-in acoustic ceiling tiles in the 2nd level classroom area.

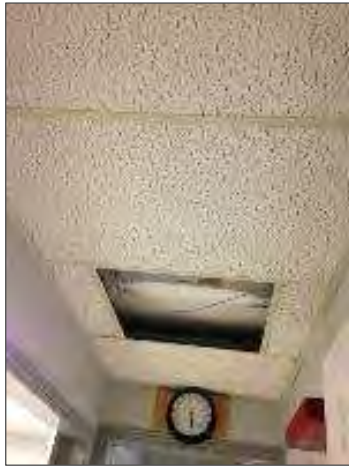
Photo 7 – Non-asbestos 24" x 48" lay-in acoustic ceiling tiles in the 2nd level kitchenette.

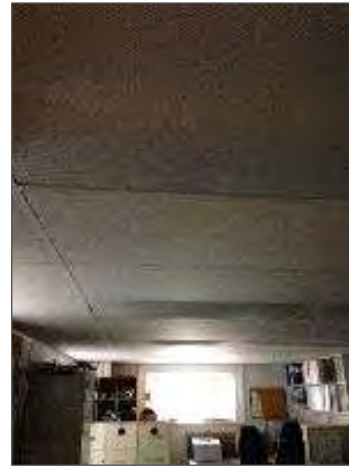
Photo 8 – Non-asbestos 24" x 48" lay-in acoustic ceiling tiles in the main floor office.

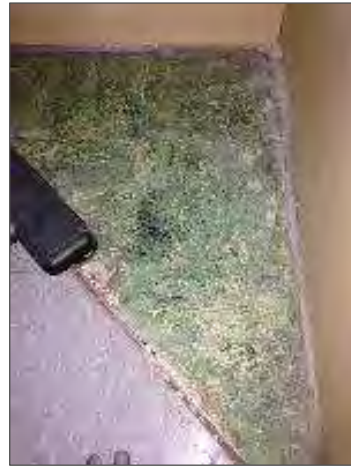
Photo 10 – Non-asbestos 9" x 9" vinyl floor tiles in the 2nd level classroom area.

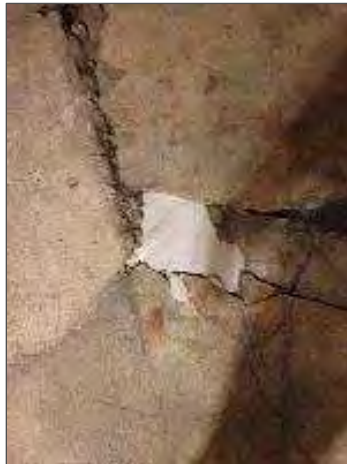
The levelling compound present in the basement does not contain asbestos (Samples 0008A-C).

Photo 11 – Non-asbestos levelling compound in the basement.

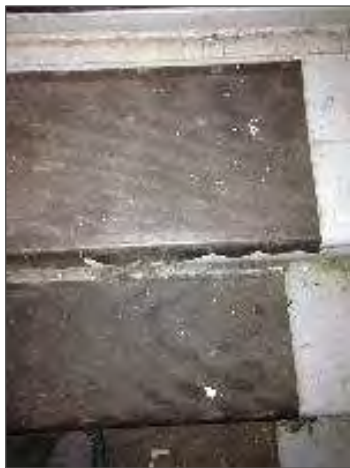
Basement and 2nd level access stair treads do not contain asbestos (Samples 0016A-C).

Photo 12 – Non-asbestos stair tread on the basement stairs.

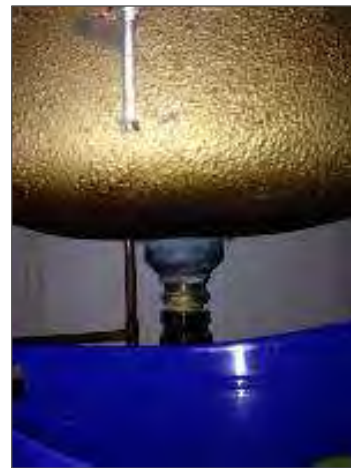
Metallic gold coating, containing chrysotile asbestos, is present on the underside of the 2nd level kitchenette sink (Samples 0017A-C).

Photo 13 – Asbestos-containing metallic gold coating on the underside of the 2nd level kitchenette sink.

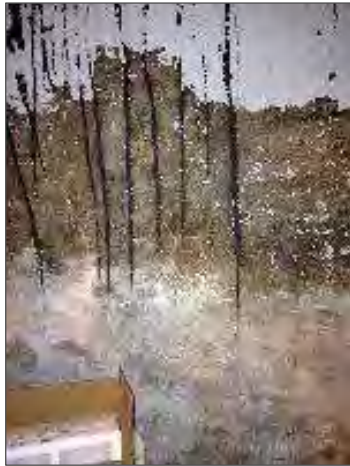
Photo 14 – Non-asbestos grey cementitious parging on the basement perimeter walls.

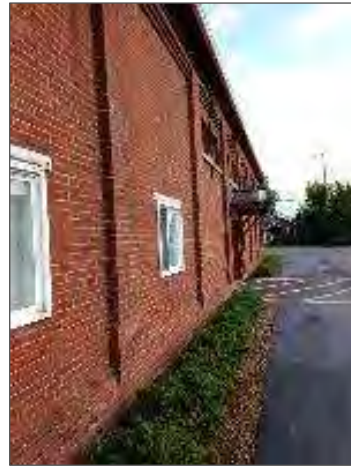
Brick mortar at the perimeter of the building is non-asbestos (Samples 0020A-C).

Photo 15 – Non-asbestos brick mortar at the perimeter of the building.

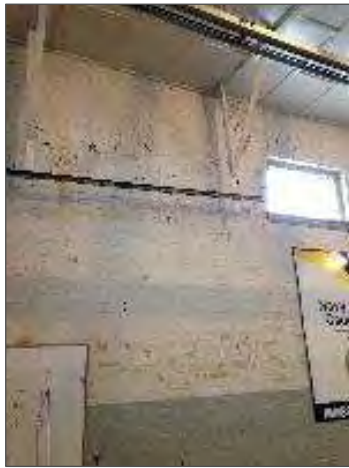
- White paint on concrete, main floor perimeter walls (Pb08).
- Light grey paint on concrete, main floor perimeter walls (Pb09).
- Red paint on wood, west elevation windows (Pb15).
- Green paint on wood, west elevation windows (Pb16).

Photo 16 – Flaking/peeling white and light grey lead-containing paint on the main floor north perimeter wall.

Material and Quantity	Location	Recommended Procedure
White and Light Grey Lead-Containing Paint (2000 ft ²)	Main Floor, Garage, Perimeter Walls	Class 2A Lead Abatement as per EACO
Red and Green Lead-Containing Paint (10 LF)	West Elevation Windows	Class 2A Lead Abatement as per EACO
Brick and Mortar	Perimeter of Building	Class 2A Lead Abatement as per EACO
Interior of Building	All Surfaces and Finishes	Clean Following Class 1 Lead Abatement as per EACO

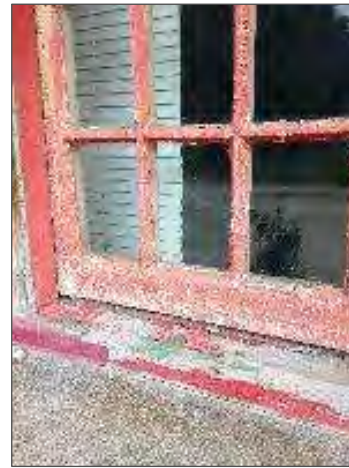
Photo 17 – Flaking/peeling red and green lead-containing paint on the west elevation windows.

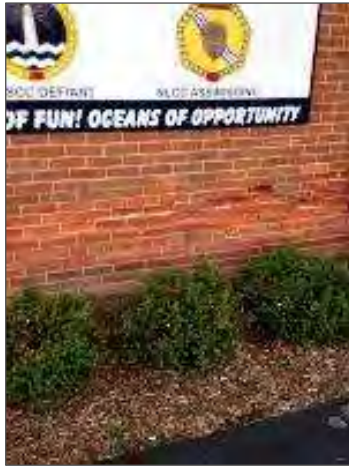
Photo 18 – Spalling lead-containing brick and mortar along the south elevation.

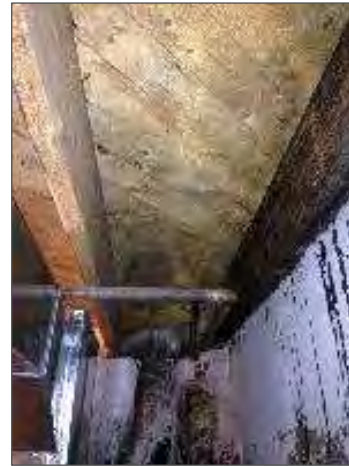
Lead contamination was found on unpainted wood joists in the basement (Sample Pb08).

Photo 19 – Lead-contaminated unpainted wood floor joists in the basement.

The paint samples were confirmed to contain elevated levels of lead; however, to a lesser degree than the initial analysis indicated. The bulk sample was found to contain insignificant levels of lead.

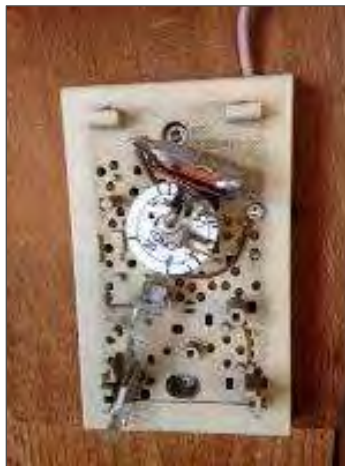
Mercury is present as a liquid in thermostats.

Photo 20 – Liquid mercury is present in thermostats.

Do not break lamps or separate liquid mercury from components. Recycle and reclaim mercury from fluorescent lamps and thermostats when taken out of service. Liquid mercury is classified as a hazardous waste and must be disposed of in accordance with local regulations.
